AN IMPROVED PLUGGING SYSTEM FOR HX TUBING

PRESENTED AT EPRI BOP CONFERENCE, JUNE 1996

Abstract

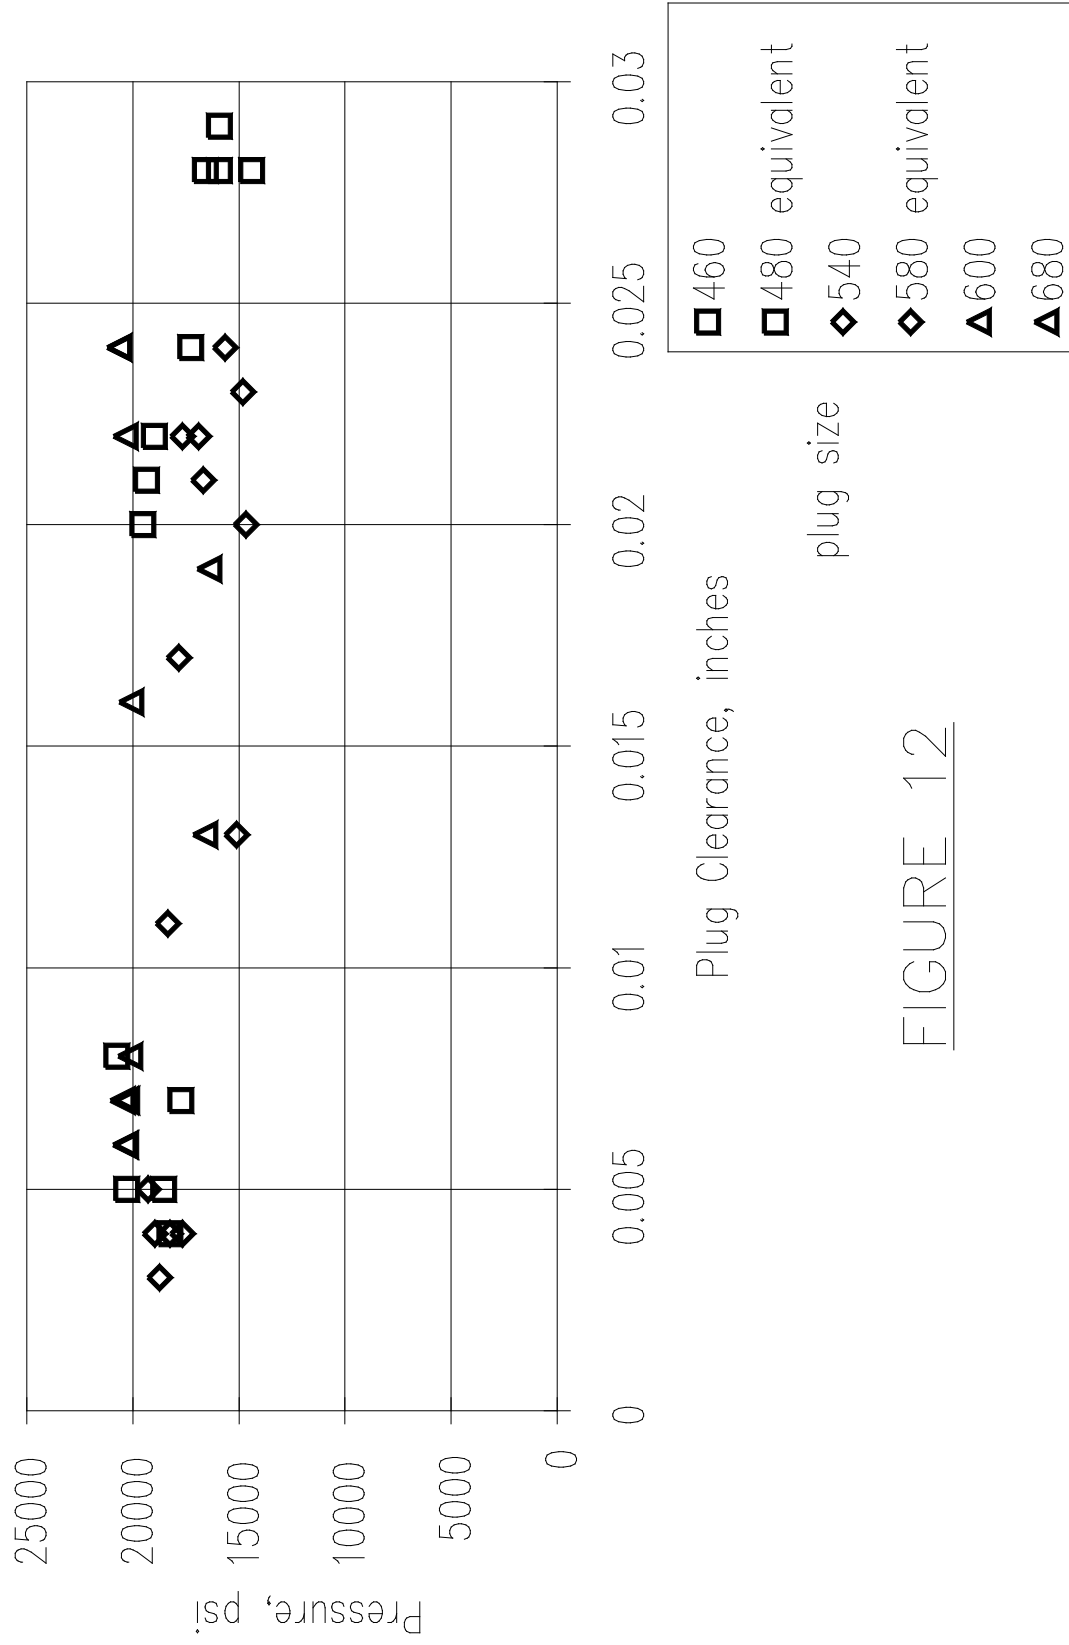
FIGURE 12

CRS P2 Blowout Pressure

Other tests are routinely run to increase the pressure across the plug until it is ejected from the tube. This is done using the test set-up shown in Figure 11 that is limited to slightly over 20,000 psi. Results of testing carbon steel plugs with the test coupons prepared by power brushing are shown in Figure 12. Figure 12 shows performance in several popular sizes for high pressure heat exchanger tubes as well as the effect of the initial clearance between the plug OD and tube ID. It is seen from this data that the plugs will perform well beyond the 0.020 size range permitted by the “go-no go” gage system. If the “no go” end of the gage will not enter

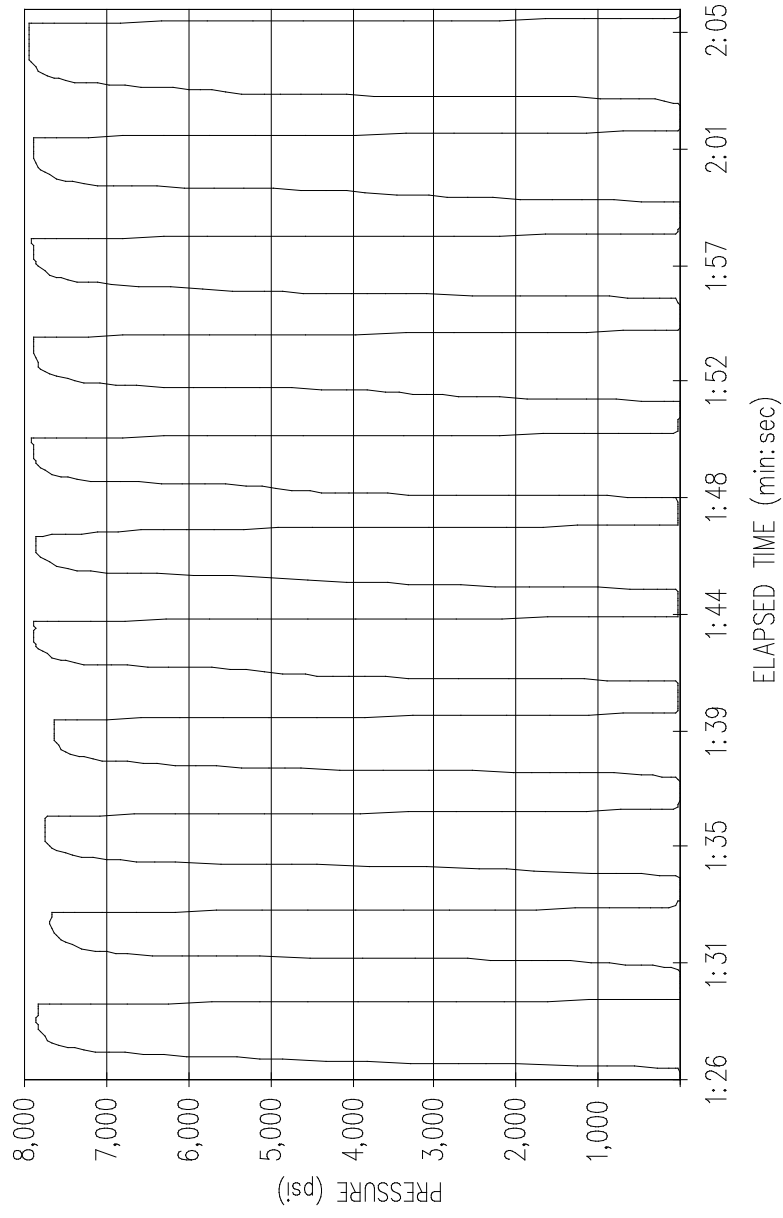
FIGURE 18

.400 CRS P2 PRESSURE CYCLING TEST

A pressure cycling test was conducted by shocking the plugs with over 100 cycles of 0 to 7000 psi using the set-up in Figure 11. The pressure was cycled between atmospheric and 7000 psi by manually operating the shut-off and bleed valves. This was done rapidly to create a pressure change that is shown in Figure 18. The plugs were monitored for leakage and none was observed. Blowout tests at the conclusion showed no loss of gripping power as the blowouts were in excess of 19,120 psi.
