EST Group

Double Block and Bleed Test & Isolation Plug

Novel Isolation Approach Brings Speed, Safety, and Security to Pipeline Valve Replacement

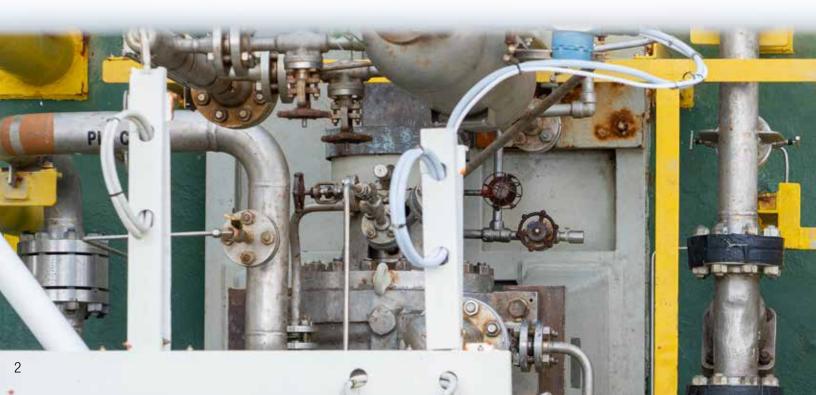
Figure 1 - The DBB housed in the spool assembly prior to deployment (top), and after it has been deployed through the valve and into its setting position by the push rod (bottom).

Working in collaboration with its Australian distributor PipeServ, EST Group developed a customized plug and installation strategy, with the ultimate goal of making plug installation as efficient, seamless, and risk-free as possible, without adding to the operator's maintenance budget. The solution included a custom launching spool assembly that housed a specially designed, hydraulically actuated DBB Test & Isolation Plug (see figure 1).

The launching spool and DBB were designed to safely isolate the valve during changeout through the following installation process. First, the spool assembly was attached to the valve flange. Then, the DBB was inserted into the spool assembly with a lanyard and the chamber was sealed with a flange. Nitrogen gas was introduced between the flange and the DBB plug to displace all oxygen from the system.

was pushed out of the launching spool assembly, through the valve and extended into the line with a long push rod to isolate the valve flange while the upstream chamber was pressurized with nitrogen. The assembly was designed to ensure that the DBB would be positioned in the line precisely where it needed to be with a predetermined measurement verification marking on the lanyard.

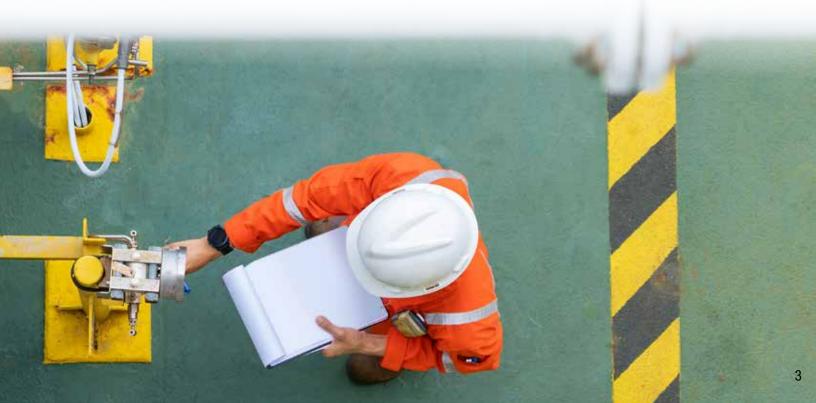
The position of the plug in the line made the conventional actuation process of mechanically activating the plug by manually torquing the nuts on the shaft of the plug impossible. The system was under pressure and closed off from the atmosphere. This necessitated the special hydraulically actuated plug, which included a hydraulic piston cylinder internal to the DBB. The cylinder was activated by energizing a hydraulic hose that fed to the plug. As the cylinder moved, it compressed the seal material forming a leak-tight seal on the two locations on the pipe wall.

During deployment of the novel DBB plug, the team had to develop a way to not only extend the plug to its setting location and safely bring it back, but also maintain pressure boundaries between the hydraulic hose assembly, connections, fittings, and gauges inside the launching spool assembly and the atmosphere. The solution was to route the hose assembly around the push rod in a spiral. As the plug was moved into position, the assembly extended like an unraveling spring to ensure service to the test plug was maintained while the plug was extended. Once the seals were compressed, the hydraulics were locked and monitored and remained in the system—along with the plug and the rod.

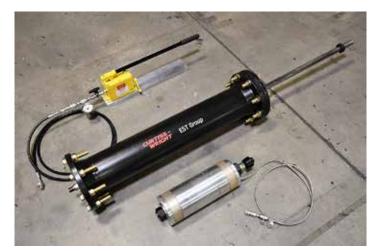
Figure 2 - The equipment required for the line isolation consisted of just three main components: a hydraulic hose line (top), the spool assembly (middle), and the hydraulically actuated DBB (bottom).
